LAFARGE CANADA INC.

# AMBIENT AIR QUALITY MONTHLY REPORT

## MAY 2020

PROJECT NO.: 171-00556-00  
DATE: JUNE 22, 2020

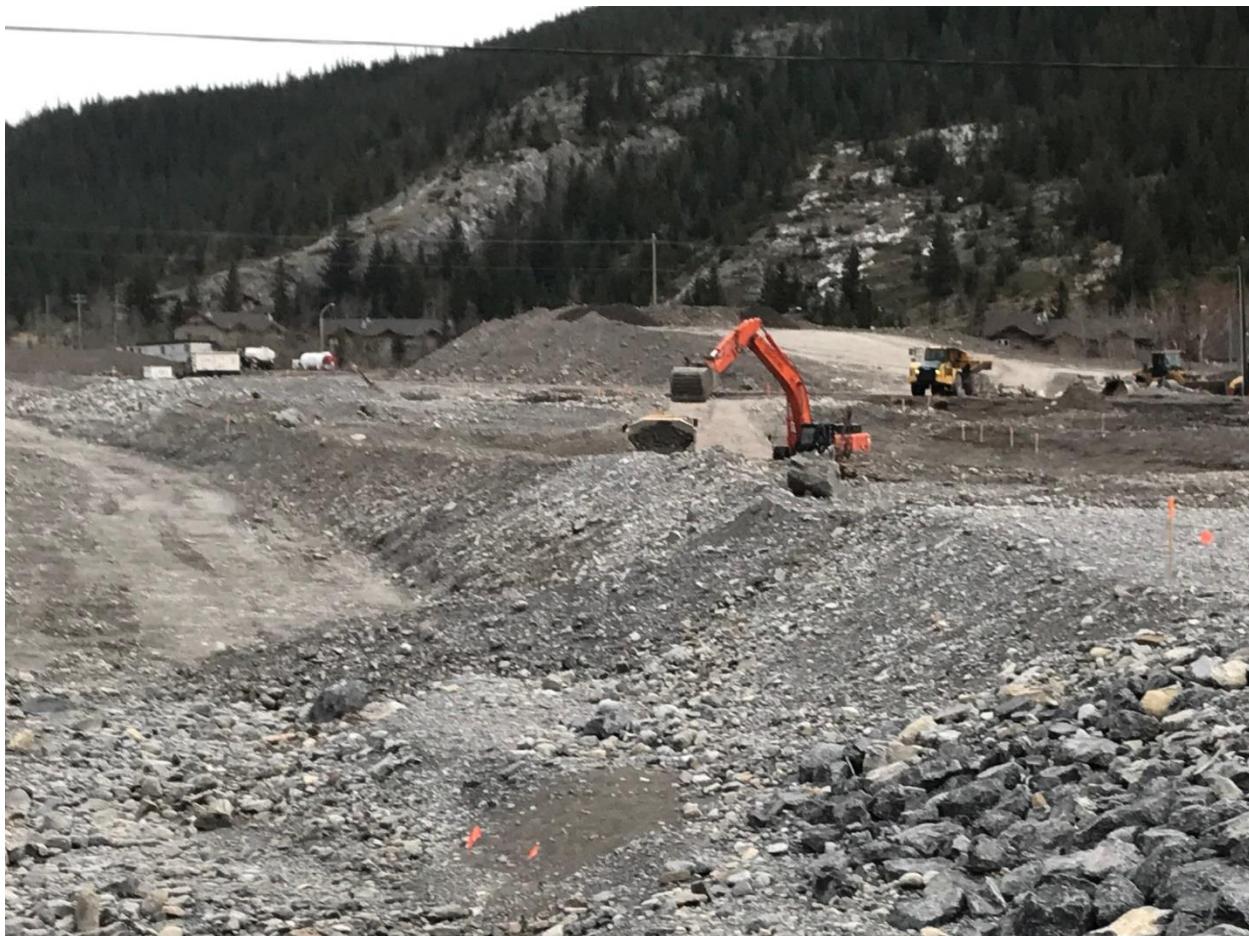
**Figure 1-1 Photo of Flood Mitigation Construction at Exshaw Creek**

Due to flood mitigation construction at Exshaw creek (Figure 1-1), the Windridge monitor was taken out of operation and removed from the site on April 8, 2019. The monitoring station will be re-installed after the completion of construction in 2020.

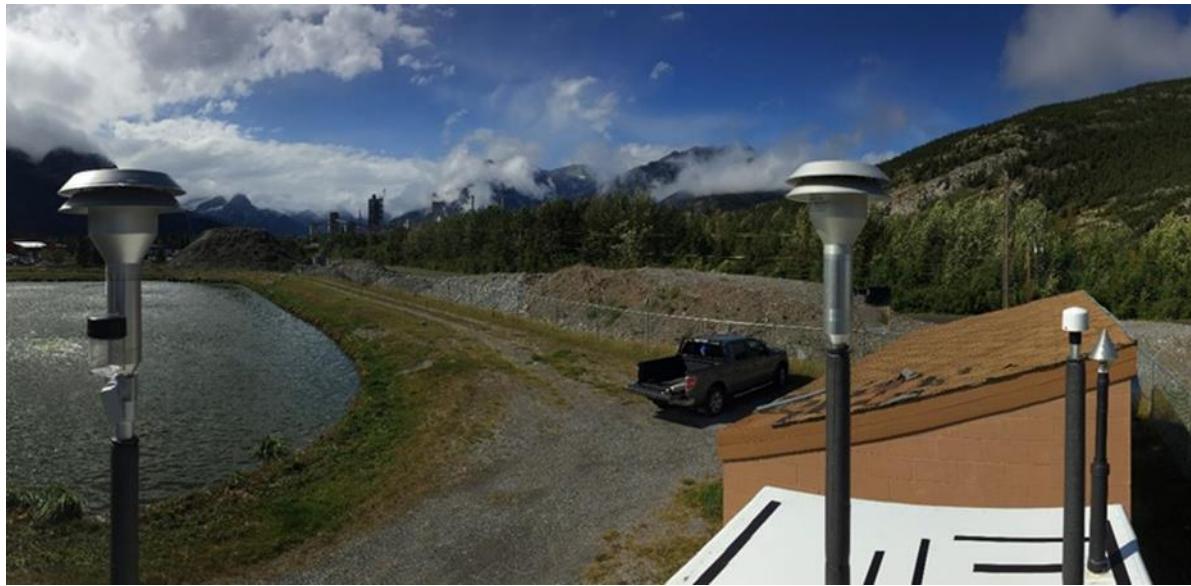
**Figure 3-1      Inlets on the top of WSP's Lagoon monitor**

The Lagoon trailer contains NO<sub>x</sub>, SO<sub>2</sub>, TSP, PM<sub>10</sub>, and PM<sub>2.5</sub> analyzers as well as meteorological sensors, and is shown in Figure 3-1. An ambient air quality station has been at this location since 2002, providing a long-term data record for air quality in the Exshaw area.

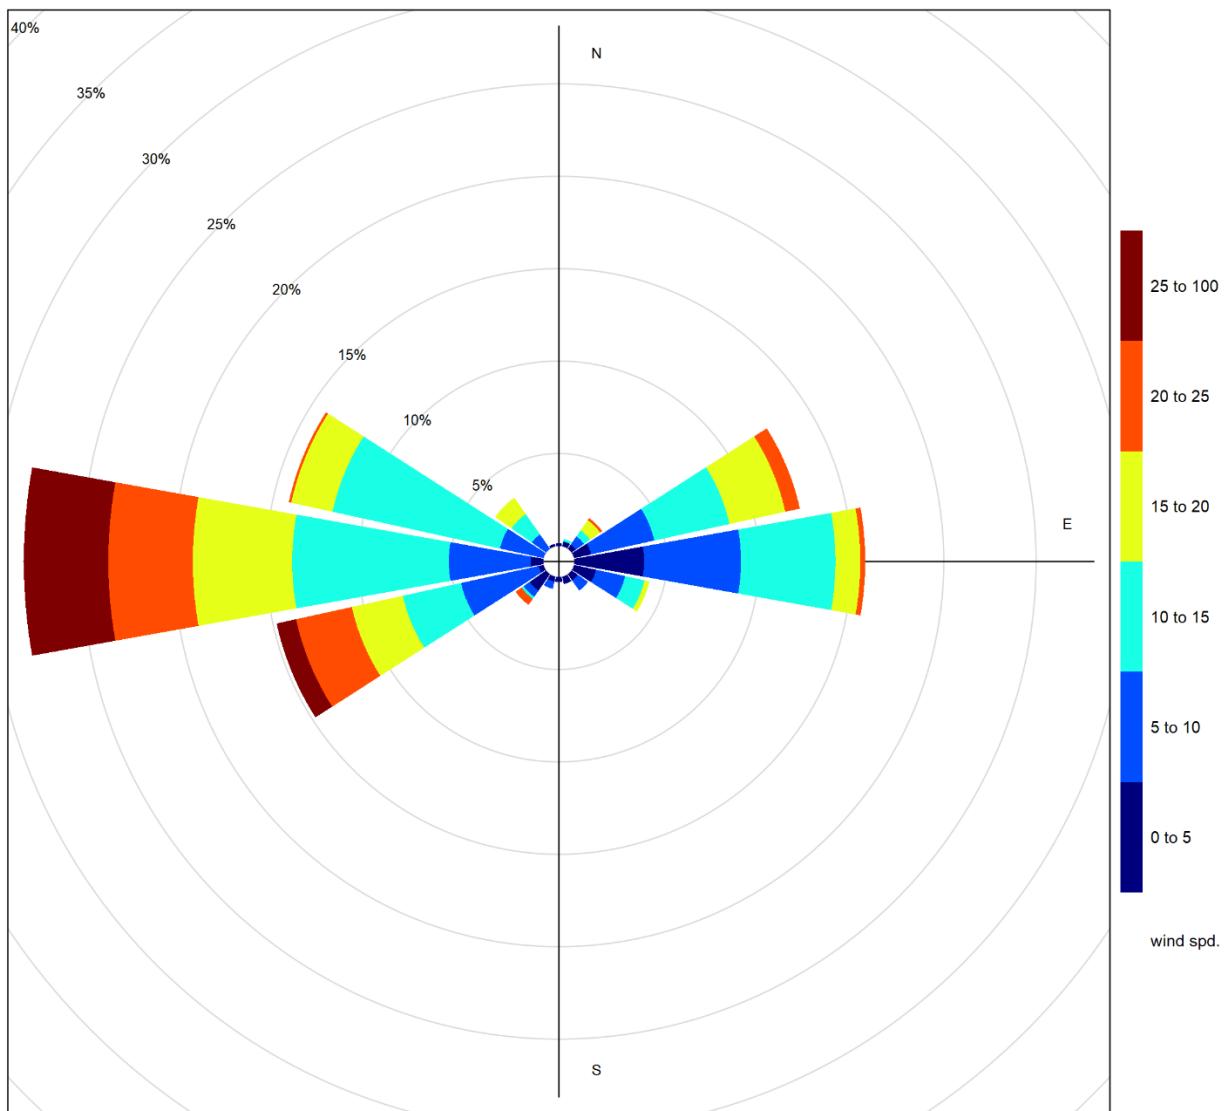
**Figure 3-2      May 2020 wind rose from the Lagoon Station**

The following wind rose (Figure 3-2) illustrates the frequency of wind speed by wind direction for the month of May 2020. The wind rose indicates that the winds predominantly came from the west direction, with lighter prevailing wind from the north-northwest, south-southwest, and east directions.

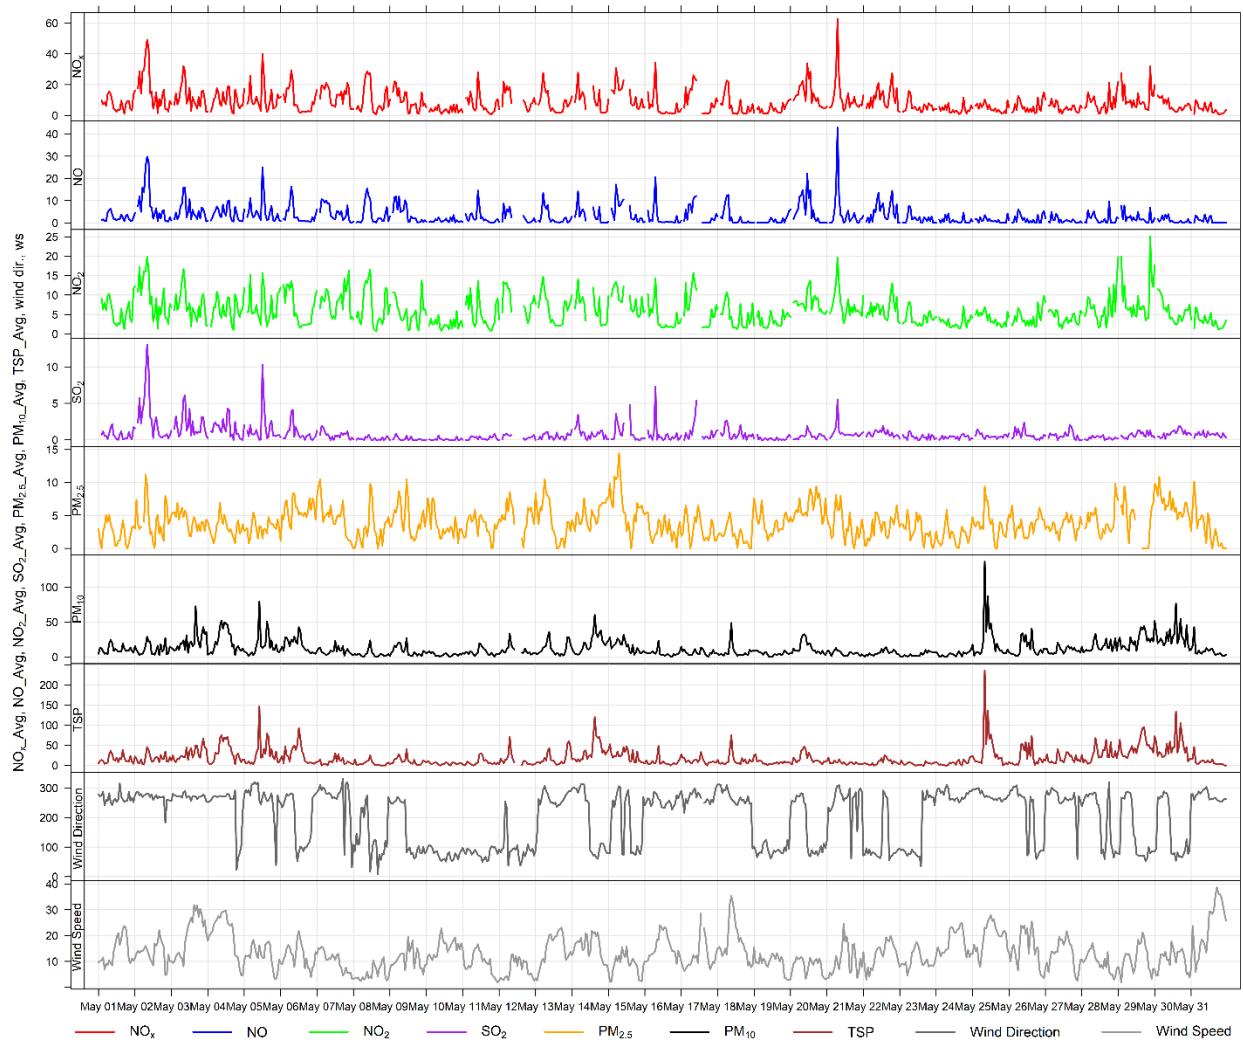
**Figure 3-3 1-hour concentrations of NO<sub>x</sub>, SO<sub>2</sub>, particulate matter, wind direction and wind speed at the Lagoon station**

Figure 3-3 graphically illustrates the time series for hourly concentrations as well as wind speed and direction, while Figure 3-9 shows daily average concentrations recorded during May 2020 for the pollutants listed in Table 3-2. Additionally, Figure 3-4 to Figure 3-8 show the histograms of the hourly concentrations of NO<sub>2</sub>, SO<sub>2</sub>, PM<sub>2.5</sub>, PM<sub>10</sub>, and TSP measured at the Lagoon station.

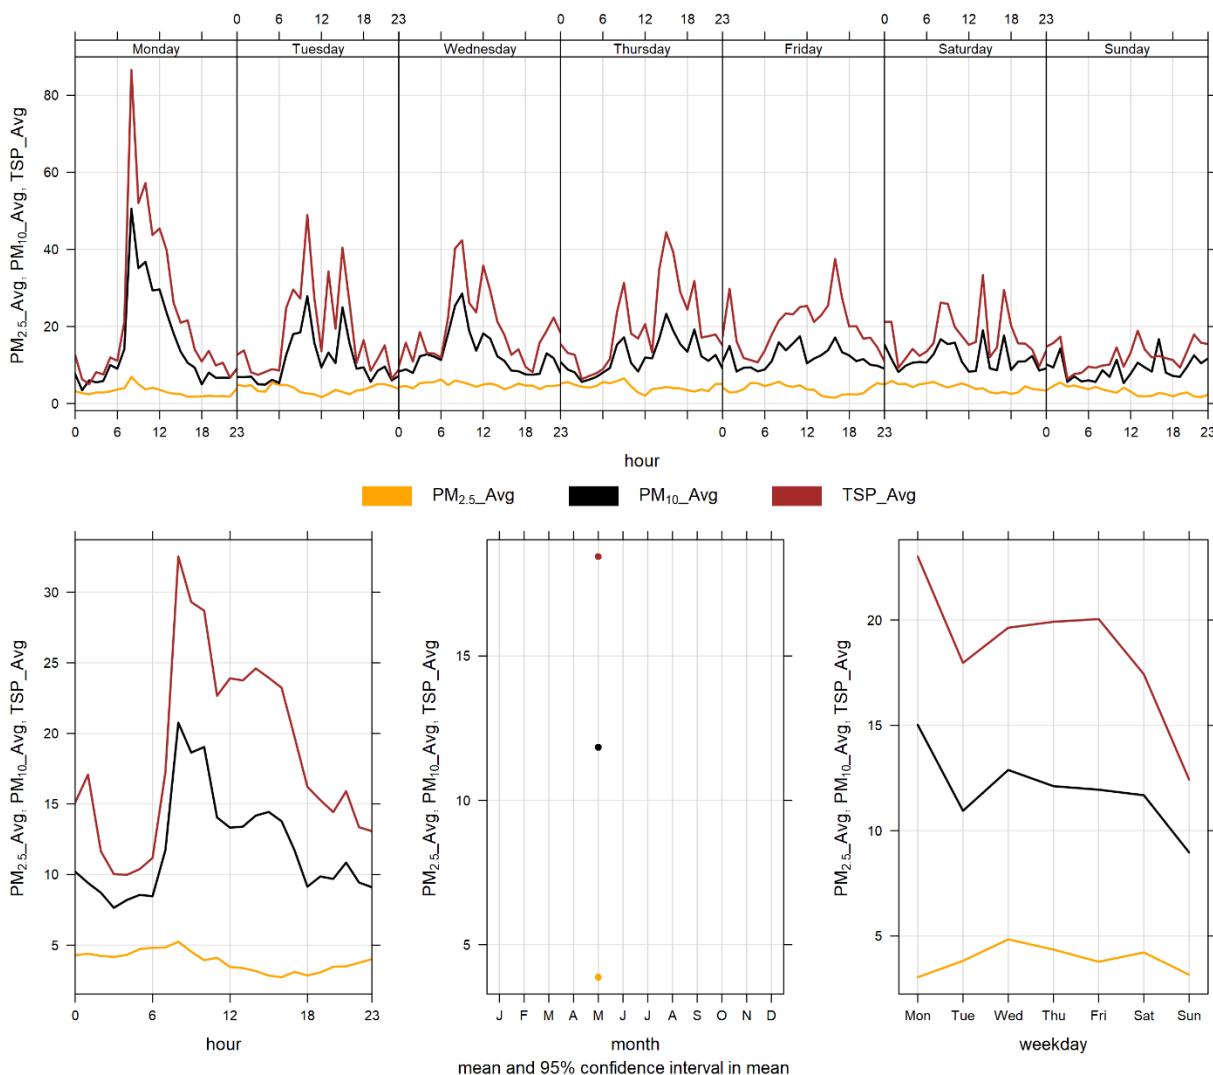
**Figure 3-10      Lagoon monitor particulate matter time variation**

Figure 3-10 through Figure 3-12 show the variation in concentrations over various time averaging periods for PM, SO<sub>2</sub> and NO<sub>x</sub>. The particulate matter plot in Figure 3-10 shows that PM<sub>10</sub> and TSP concentrations shows a diurnal pattern associated with Lafarge operations, daytime emissions from traffic and other activities. The diurnal patterns also follow the diurnal pattern of higher wind speeds during the daytime hours.

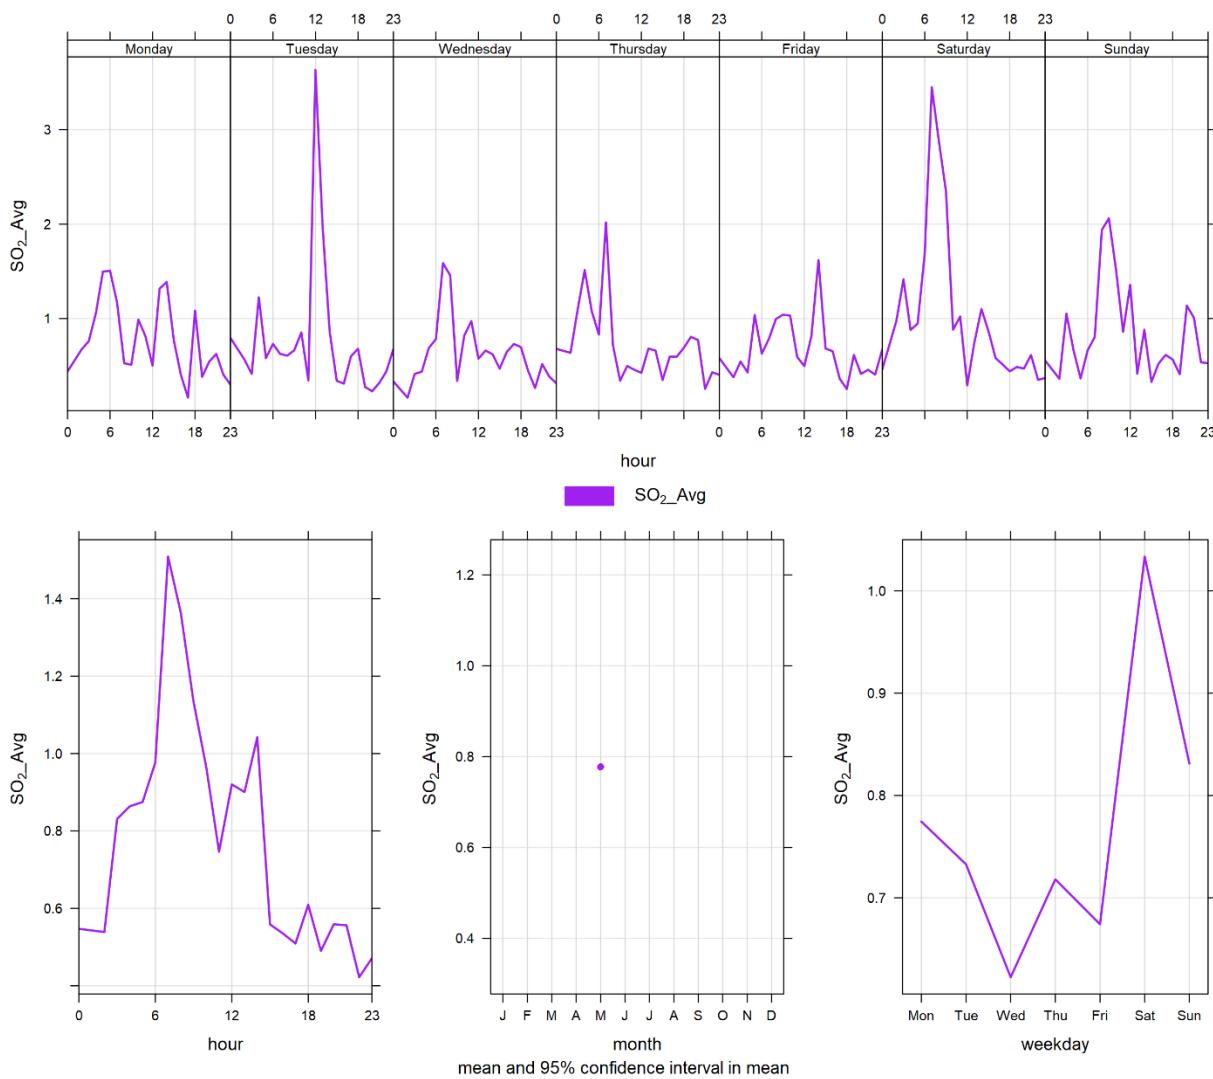
**Figure 3-11      Lagoon monitor  $\text{SO}_2$  time variation**

Figure 3-11 shows the variation of SO<sub>2</sub> over various time periods. SO<sub>2</sub> concentrations patterns are dependent on the timing of the highest SO<sub>2</sub> concentrations recorded in the month because in general SO<sub>2</sub> concentrations are very low. Figure 3-12 shows the variation of NO<sub>x</sub>, NO and NO<sub>2</sub>, with the peak of all three pollutants occurring in the early morning. This may be indicative of a peak in traffic.

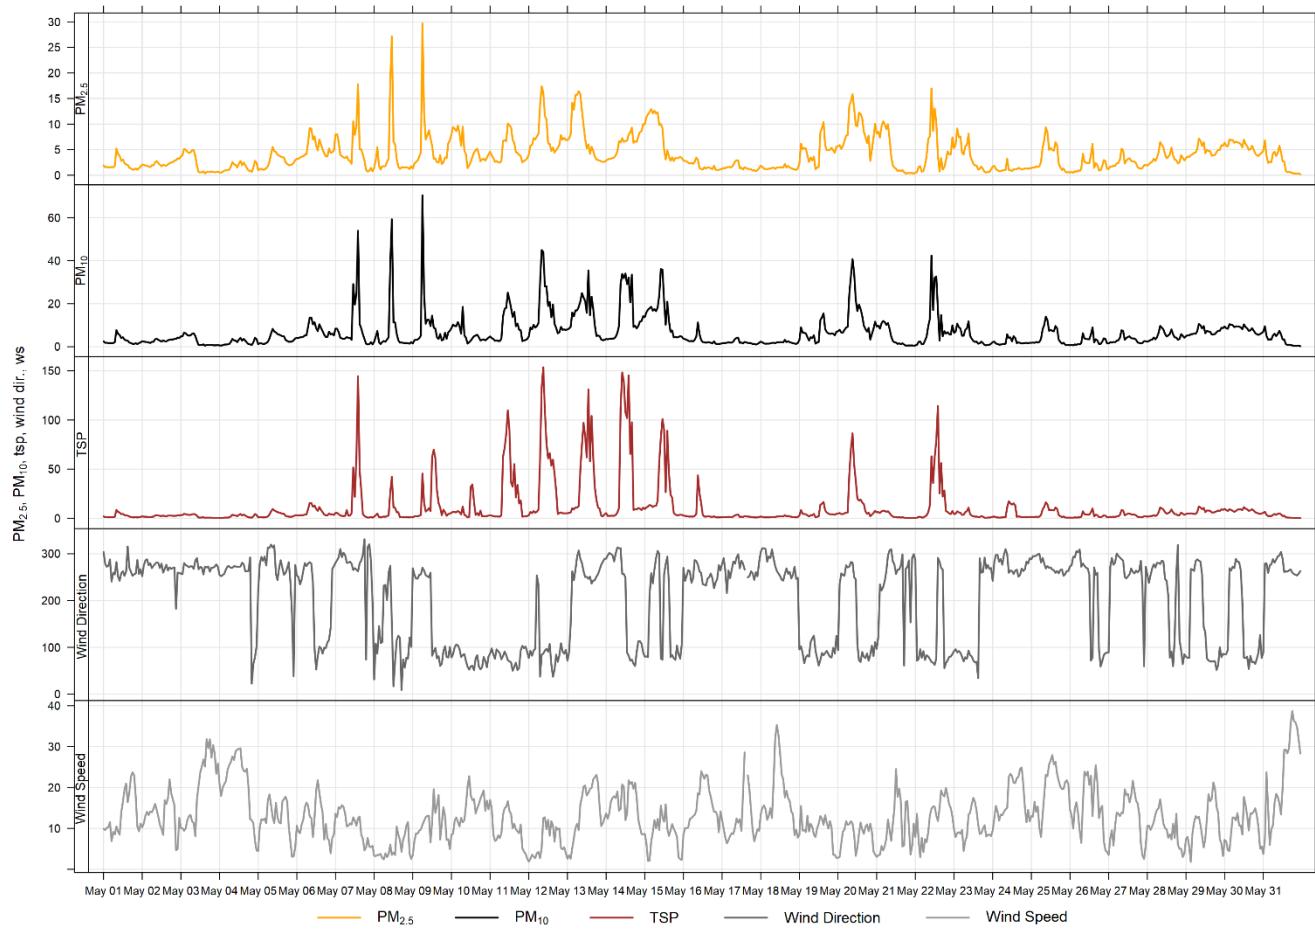
**Figure 4-1      1-hour particulate matter concentrations at the West monitor**

Figure 4-1 and Figure 4-2 show the hourly and daily PM<sub>2.5</sub>, PM<sub>10</sub> and TSP concentrations recorded over the month.

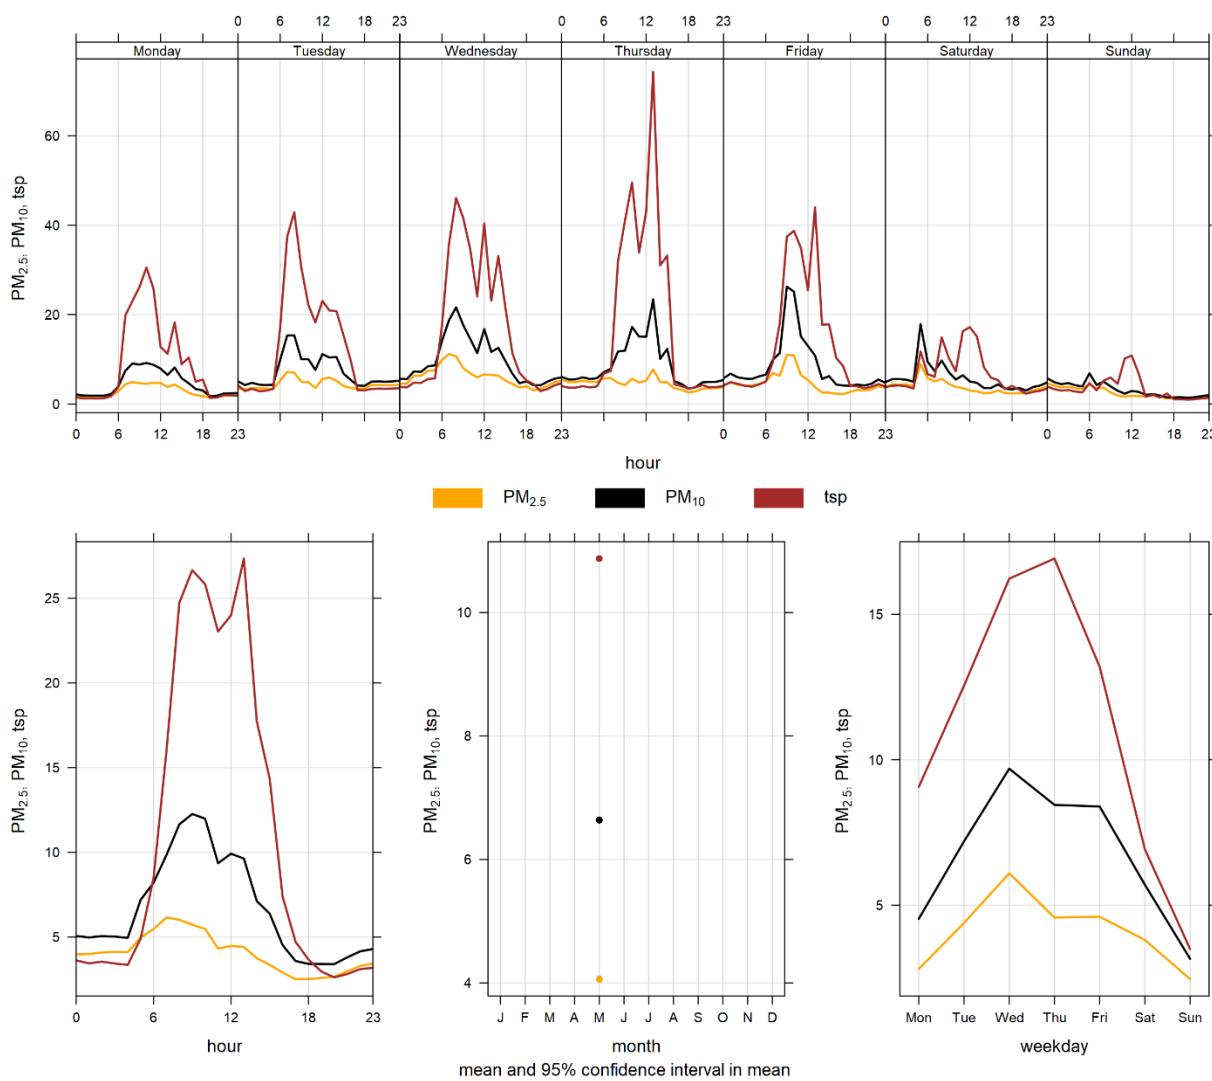
**Figure 4-3**      **West particulate matter time variation**

Figure 4-3 below illustrates the hourly PM concentrations recorded at the West monitor, averaged over different time periods. The plot across the top shows the variation of PM over the course of a week, while the bottom three plots show the changes in PM over the course of a day, month and weekday, respectively. Figure 4-3 is based on data collected during May 2020 and indicates a diurnal relationship that could be due to the proximity of the West monitor to the highway. As the monitor is generally ‘up-wind’ of the facility, the daily variations in PM are more likely a result of higher traffic volume during daylight hours than specific Lafarge operations.

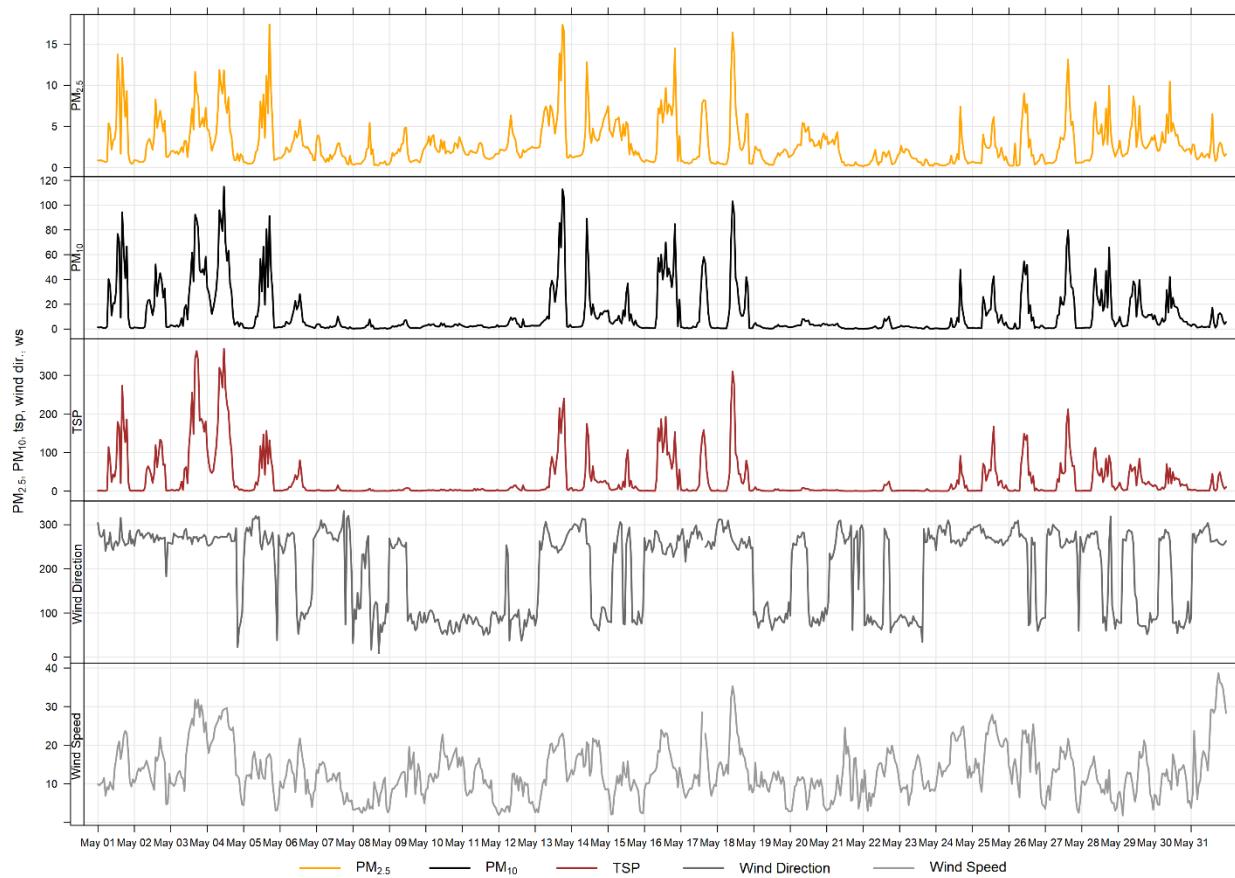
**Figure 5-1      1-hour particulate matter concentrations recorded at the Berm monitor**

The Berm monitor was placed at its current location as a result of the dispersion modelling conducted for the facility in 2009. Figure 5-1 and Figure 5-2 show the hourly and daily PM<sub>2.5</sub>, PM<sub>10</sub> and TSP concentrations recorded over the month. Table 5-2 summarizes the monthly concentrations, and the maximum 1-hour and 24-hour PM concentrations recorded during the month, and Table 5-3 summarizes the 2 recorded exceedances. This is an industrial monitor that is not Alberta Air Monitoring Directive (AMD) compliant and is not required to show compliance with the AAAQO.

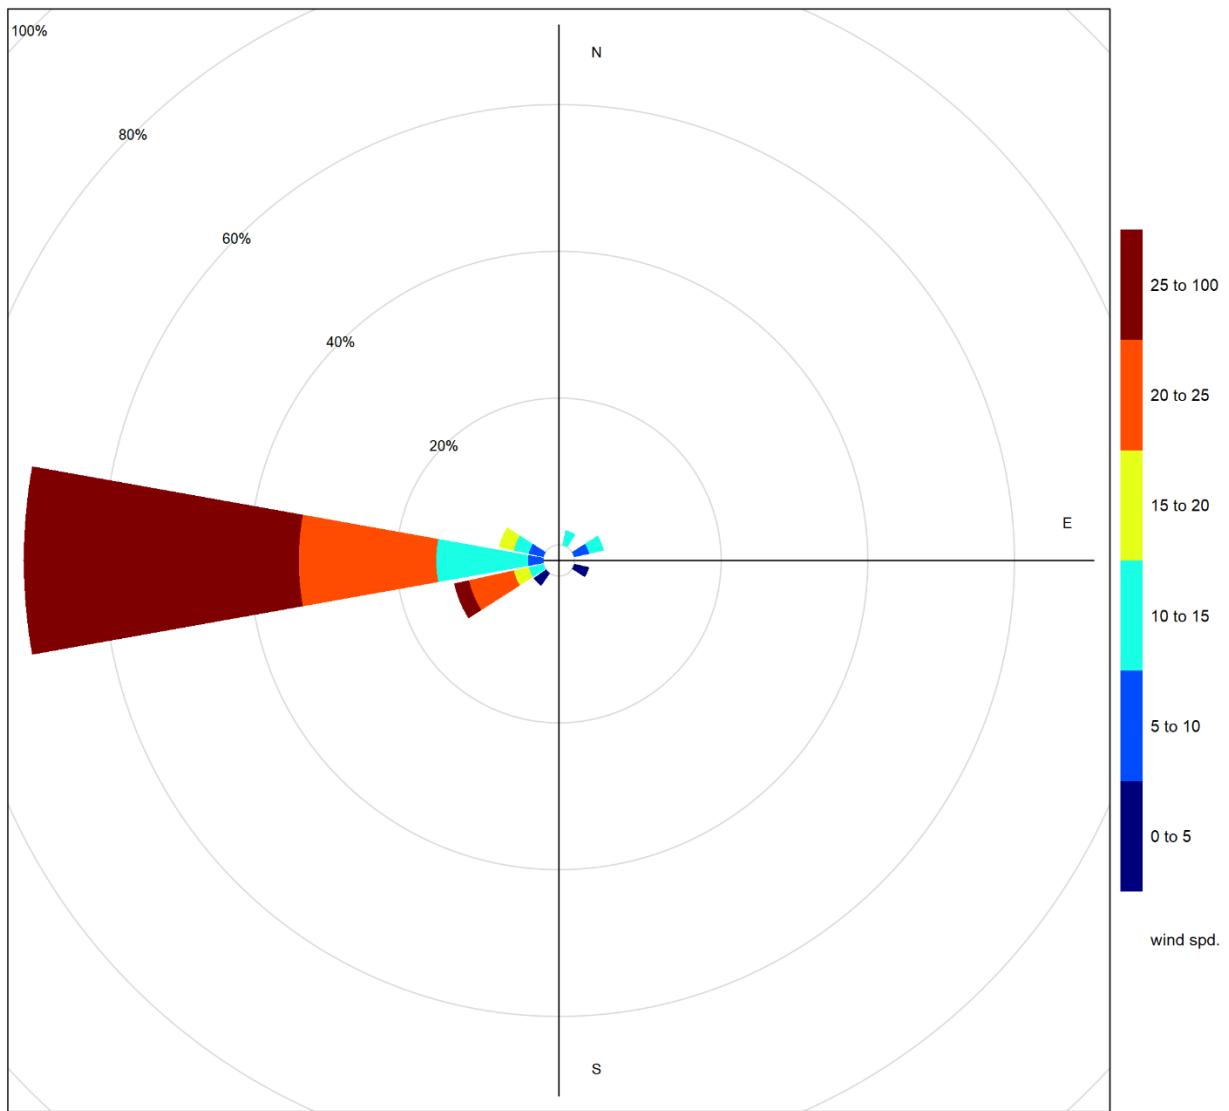
**Figure 5-3      Wind rose for TSP exceedance days recorded at the Berm GRIMM**

Figure 5-3 shows the wind rose for the two days of TSP exceedance recorded this month. The wind rose shows that the winds predominantly came from the west direction.

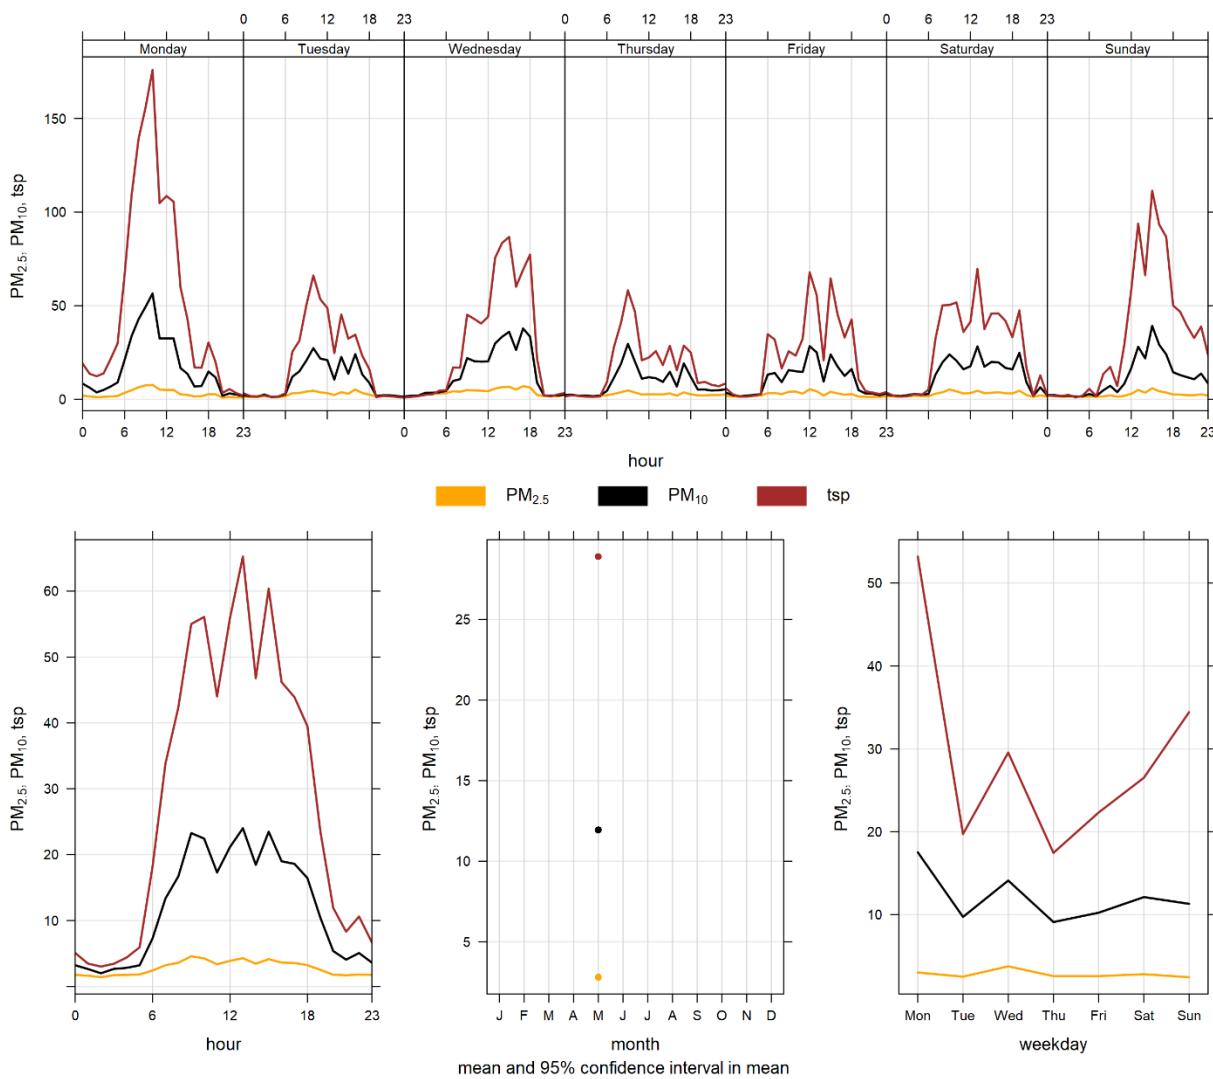
**Figure 5-4**      **Berm particulate matter time variation**

Figure 5-4 shows the variation of PM recorded at the Berm monitor over various time averaging periods. The Berm monitor diurnal pattern, similar to the Windridge and Lagoon stations, is associated with Lafarge operations, but also daytime emissions from traffic and other activities in Exshaw.

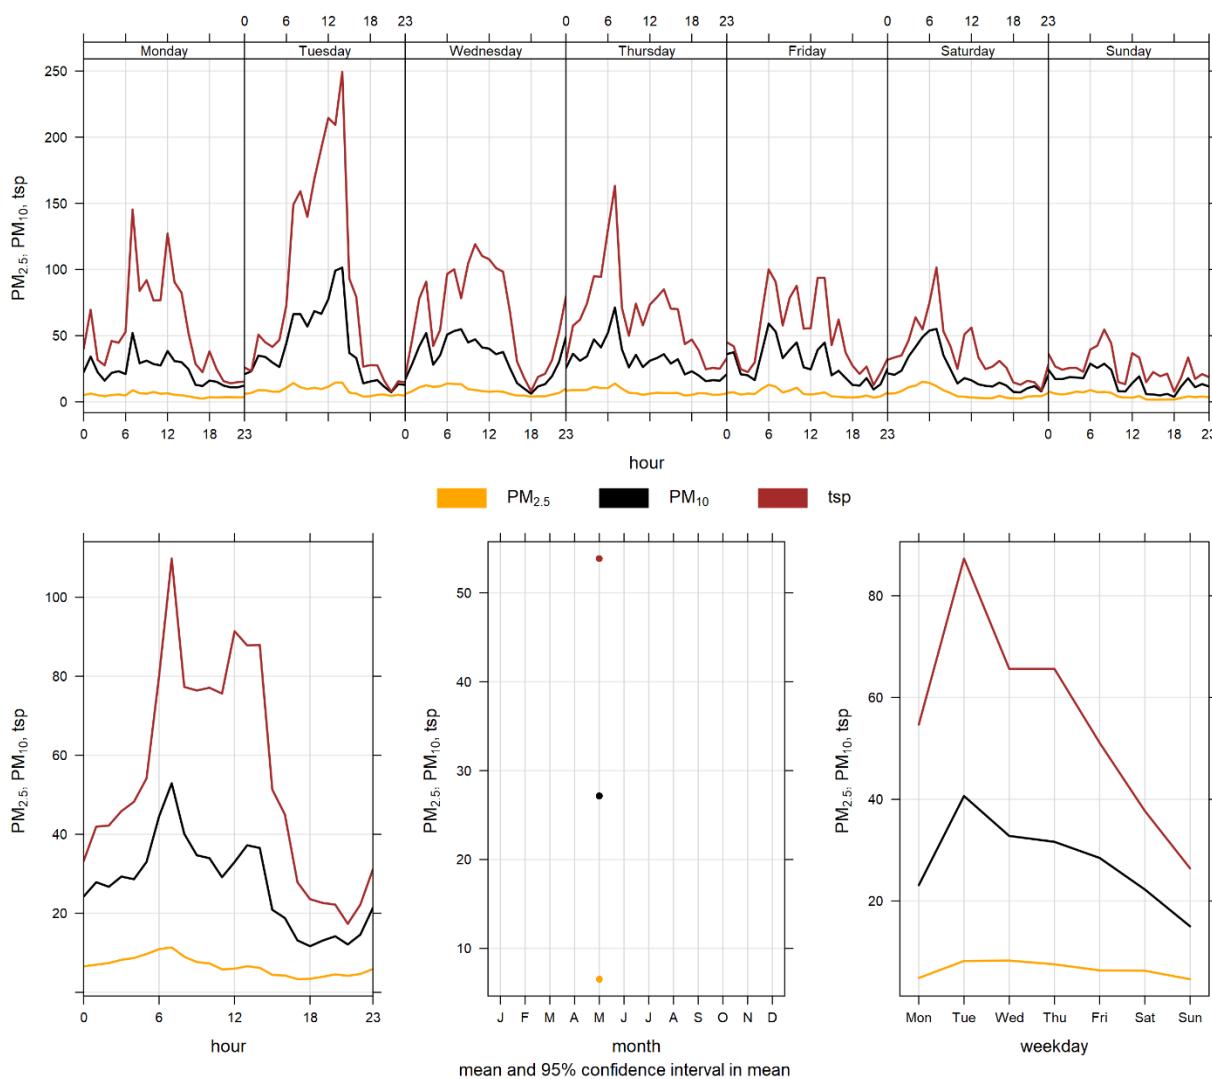
**Figure 6-4      Entrance particulate matter time variation**

Figure 6-4 illustrates the hourly PM concentrations recorded at the Entrance monitor, averaged over different time periods. The plot across the top shows the variation of PM over the course of a week, while the bottom three plots show the changes in PM over the course of a day, month and weekday, respectively. Figure 6-4 is based on data collected during May 2020. The diurnal pattern is likely more influenced by daytime traffic emission (from vehicles serving Lafarge as well as regular highway traffic) given its location near the highway entrance to Lafarge, but can as well by industry and rail sources.
